# **Revision Guide for AMD Athlon™ 64 and AMD Opteron™ Processors**

Publication # <b>25759</b>	Revision: <b>3.25</b>
Issue Date: <b>June 2004</b>

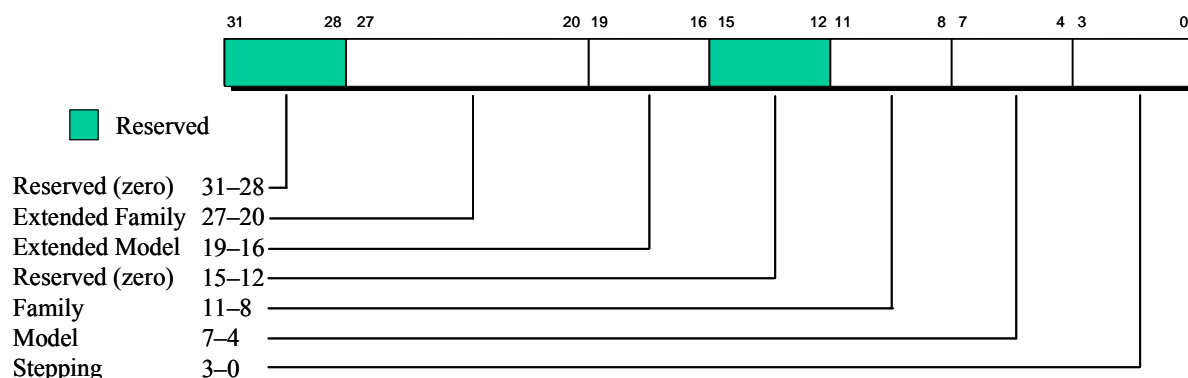
**Figure 1. Format of CPUID Value Returned by Function 1**

Figure 1 shows the format of the value returned in EAX by CPUID Function 1.
